# Reserve Advisors

Campus East Community Association, Inc. is a planned unit development which is responsible for the common elements shared by 905 unit owners. The Association was built from 1984 to 1985. The development contains asphalt pavement, playground equipment, tennis courts, a pool house and a pool. Twenty-four major common elements are likely to require capital repair or replacement during the next 30 years.

Michelle A. Stephans, PRA<sup>1</sup>, RS<sup>2</sup>, Director of Quality Assurance  
Reference #: 020700  
Visual Inspection and Report by: Anthony W. Krupka, RS  
Reviewed By: Jayme R. Radomski, PRA, RS

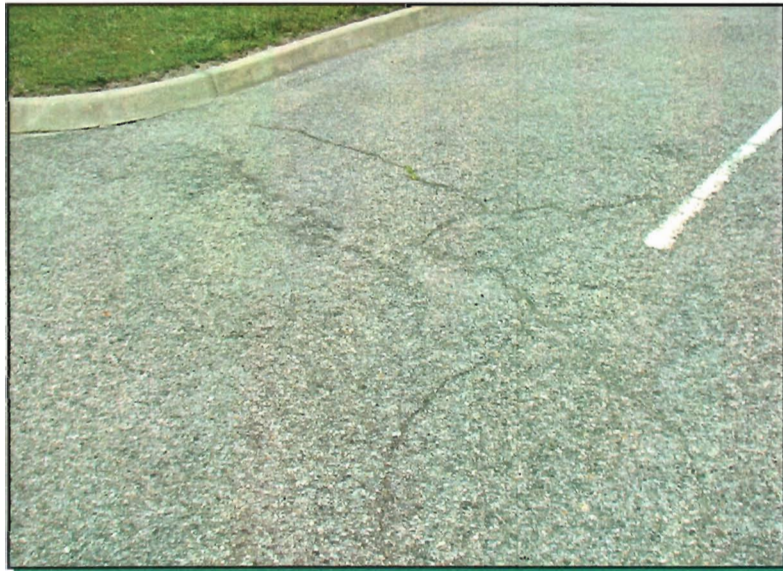
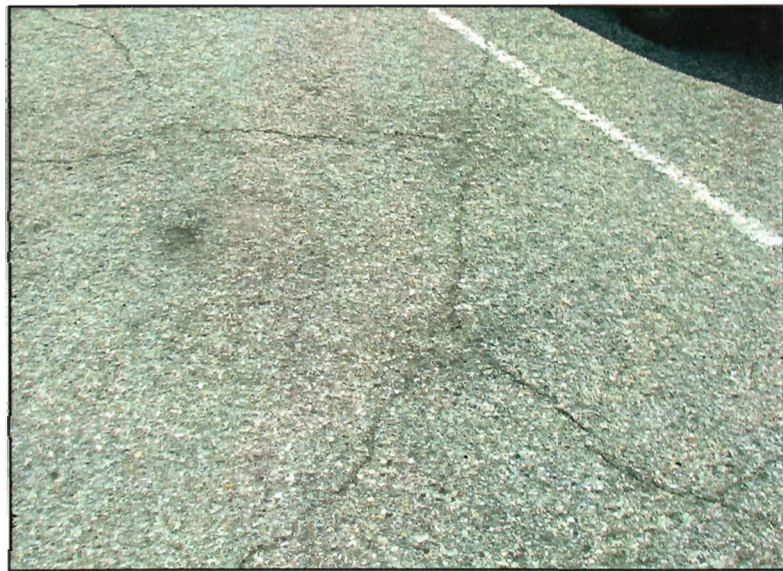
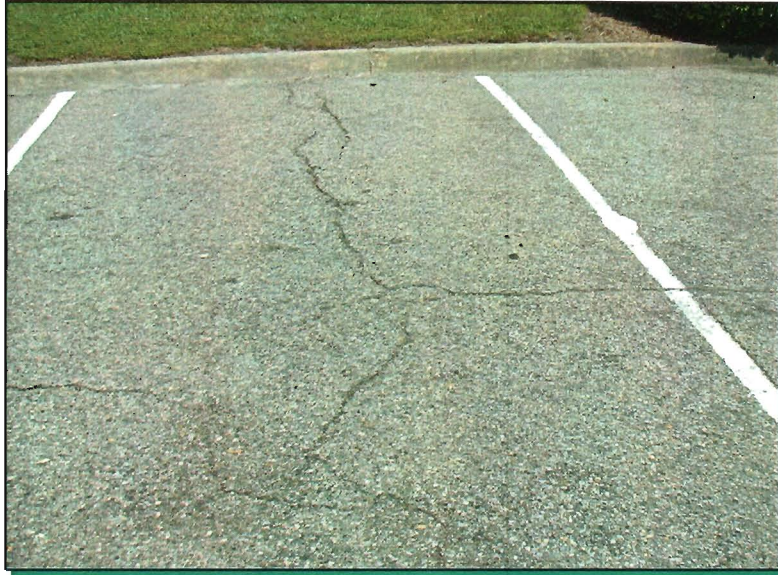
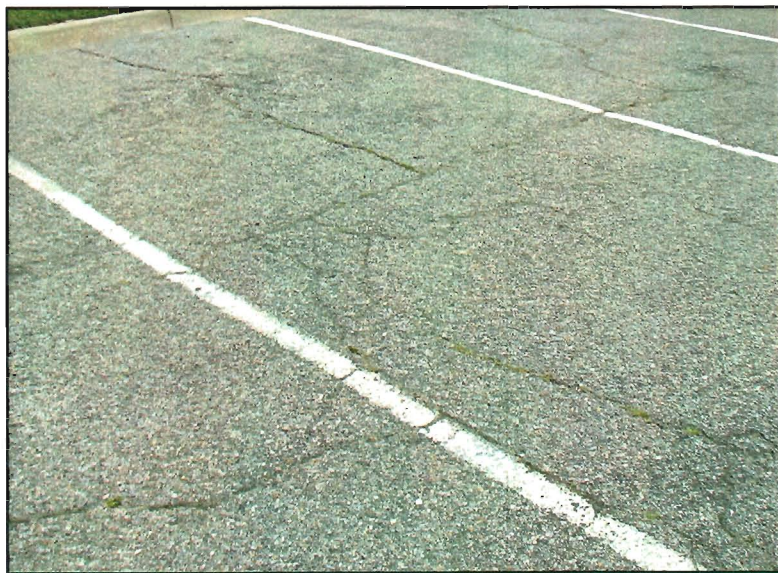
at an unknown age. We did note areas of surface cracks, raveling and potholes. We also noted evidence of a previous overlay of the asphalt pavement. Pages 1 through 3 of **Exhibit A Photographs** depict these conditions. The useful life of pavement in Virginia Beach is from 20- to 25-years. We include the following solutions and procedures pertaining to *components* of the pavement, the *manner of repaving*, *time* of repaving and *coordination* of other possible replacements with the repaving for the benefit of the present and future board members.

Cracked and surface raveled  
asphalt pavement

We recommend that Campus East plan the next application of seal coat in 2009 and subsequent applications every four years thereafter except when repaving occurs. Line Item 1 of **Exhibit B Reserve Expenditures** notes our estimate of future costs and anticipated times of seal coat applications.

apparent visual condition of the asphalt pavement and evidence of a previous pavement overlay, we recommend the *total replacement* method for initial repaving and the *mill and overlay* method for subsequent repaving at Campus East.

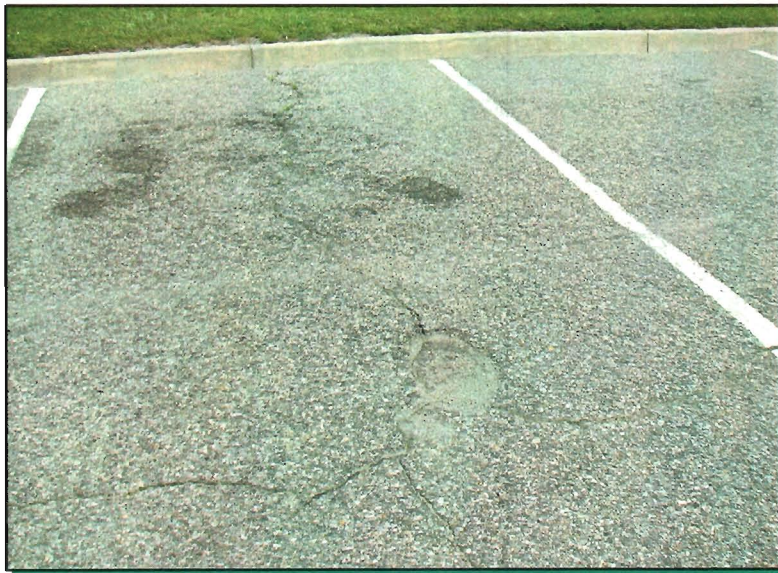
Cracked, surface raveled and  
evidence of a pothole at the  
asphalt pavement

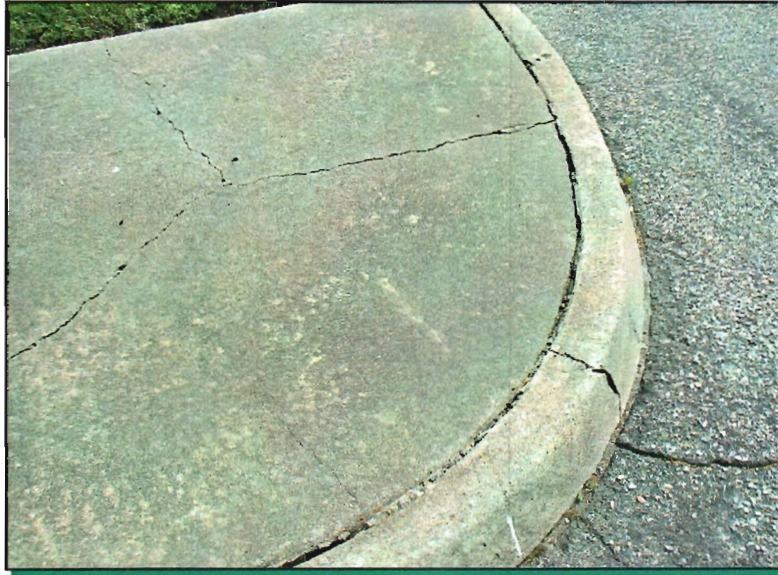
**Concrete Curbs and Gutters** - Concrete curbs and gutters line the pavement of Campus East. These curbs and gutters comprise 430 linear feet and are in good to fair condition, overall. We estimate that up to 130 linear feet of curbs and gutters, or thirty percent (30%) of the total, will require replacement in conjunction with each repaving event. We depict this information on Line Item 5 of **Exhibit B Reserve Expenditures**.

Cracked concrete sidewalk and curb, evidence of previous asphalt overlay

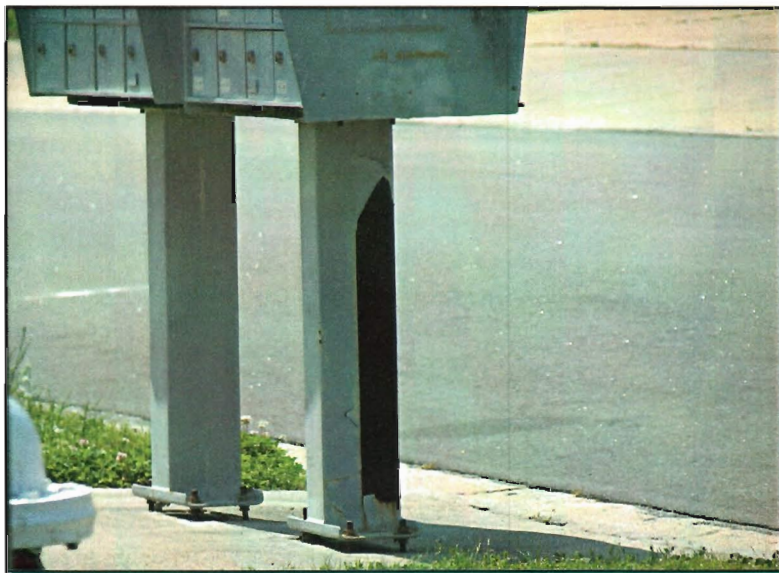
Rusted post of mailbox station  
(Post Office Responsibility)

- Mailbox Stations (*Management informs us the Post Office is likely responsible for the mailbox stations. We advise the Association contact legal counsel to determine who is responsible for replacement of the mailbox stations.*)

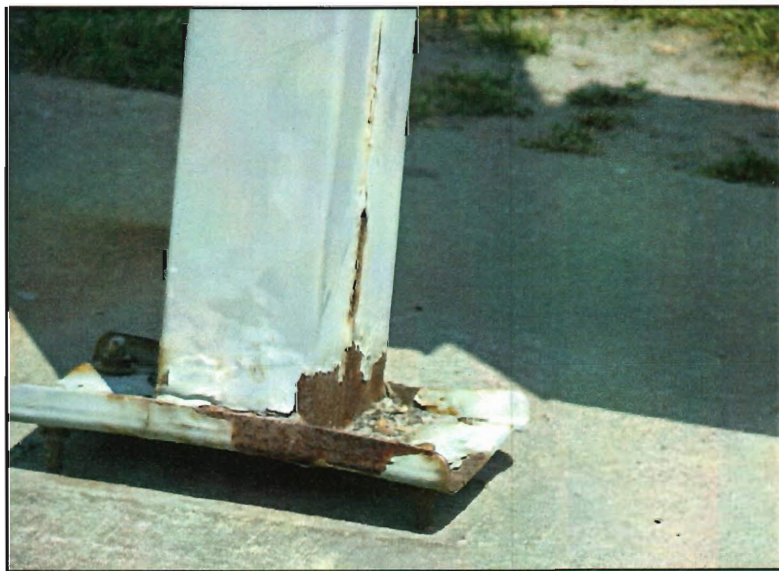
Damaged and rusted post of  
mailbox station  
(Post Office Responsibility)

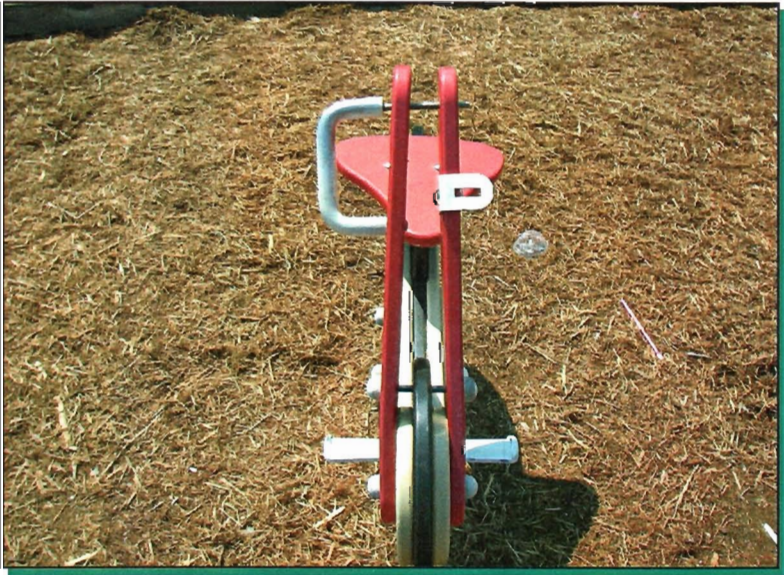
Damaged playground component

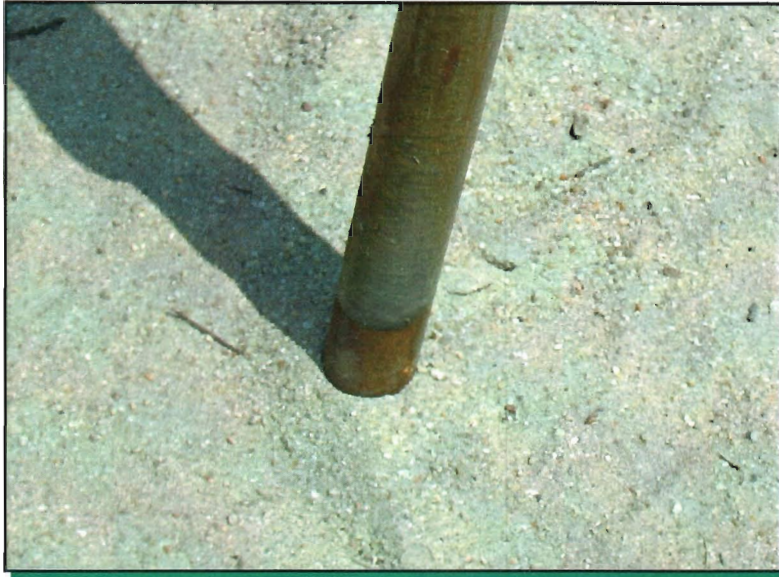
Rusted post of swing set

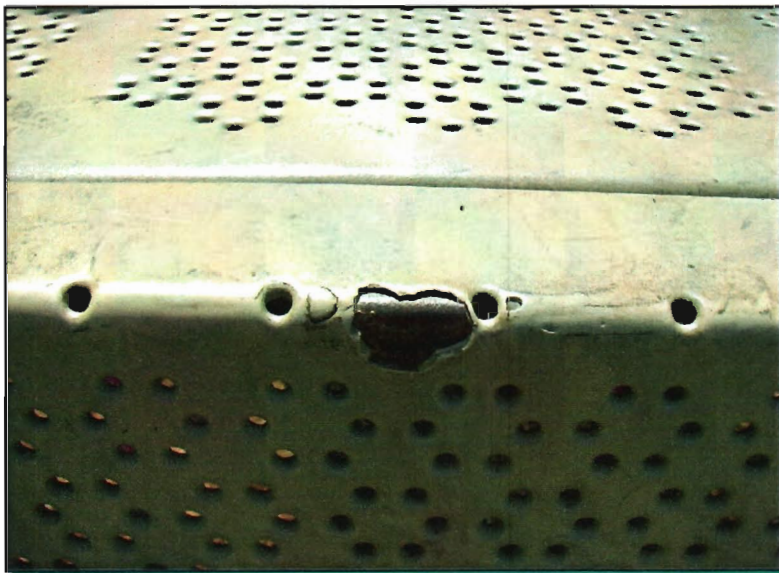
Damaged finish of playground equipment

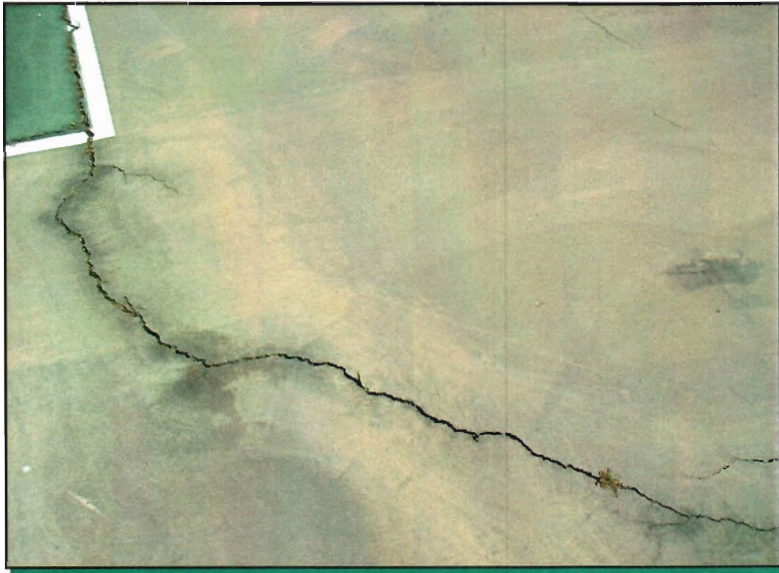
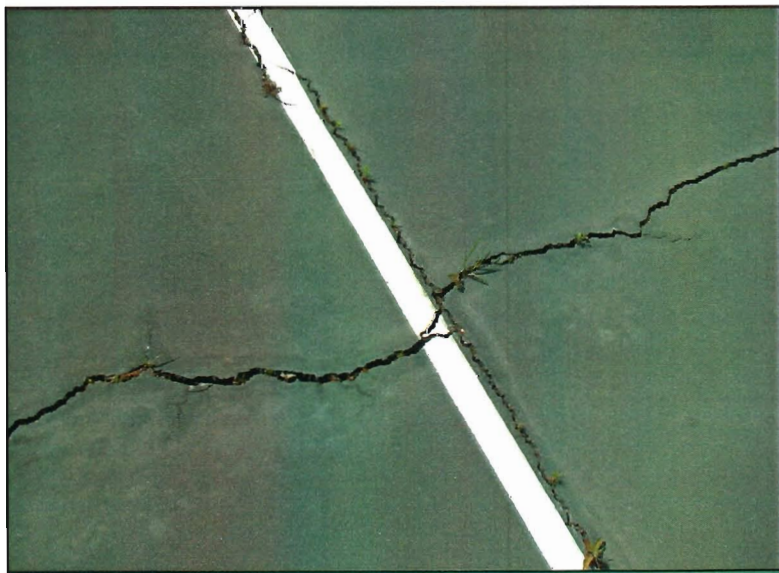
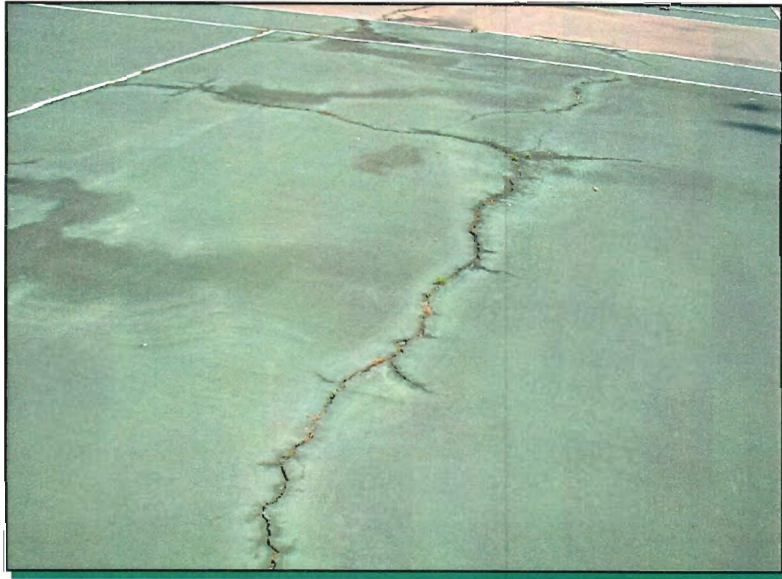
Cracked asphalt tennis court

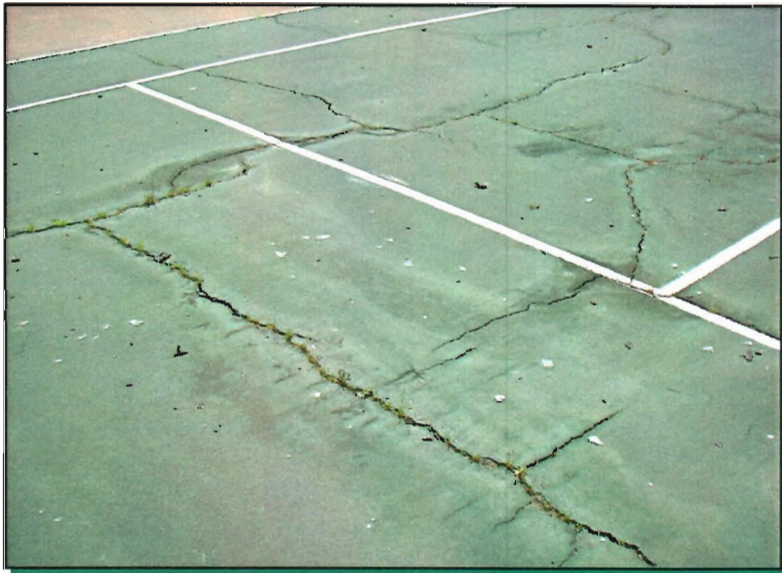
Cracked and organic growth  
through asphalt tennis court

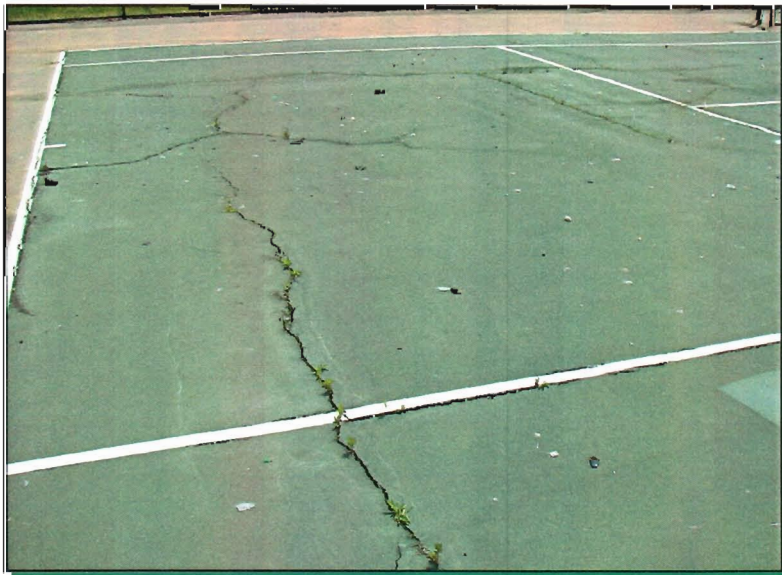
Cracked and organic growth  
through tennis court

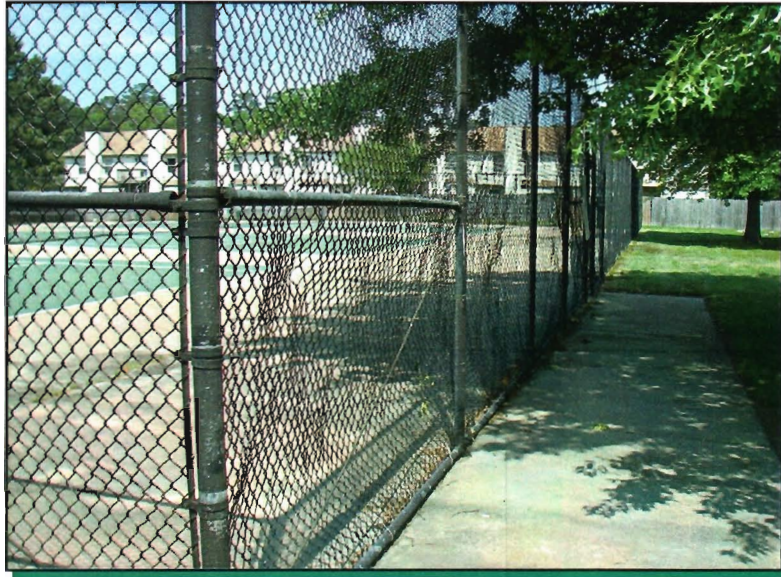
Tennis court fence - *note damaged fence sections*

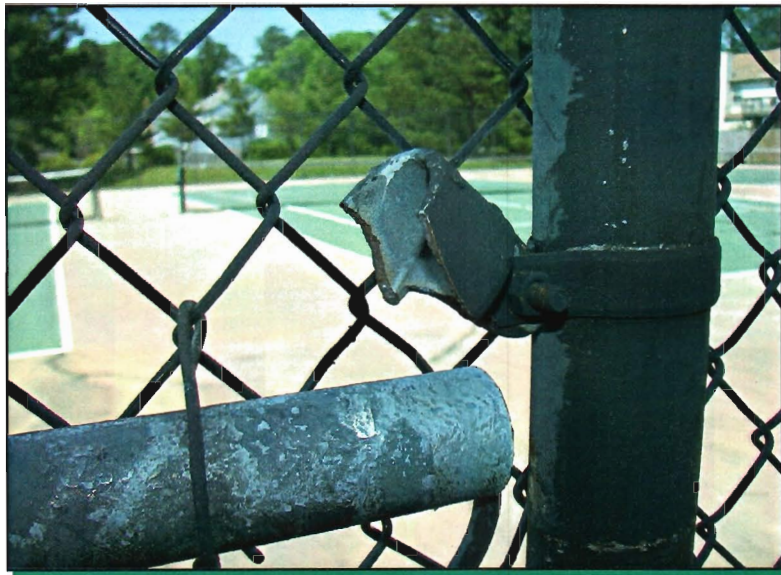
Damaged cross bar and connection of tennis court fence

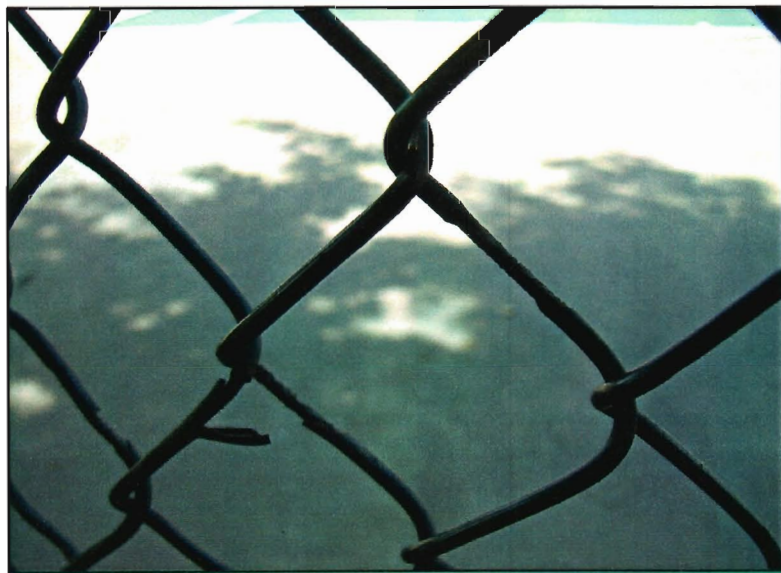
Damaged chain link section of tennis court fence

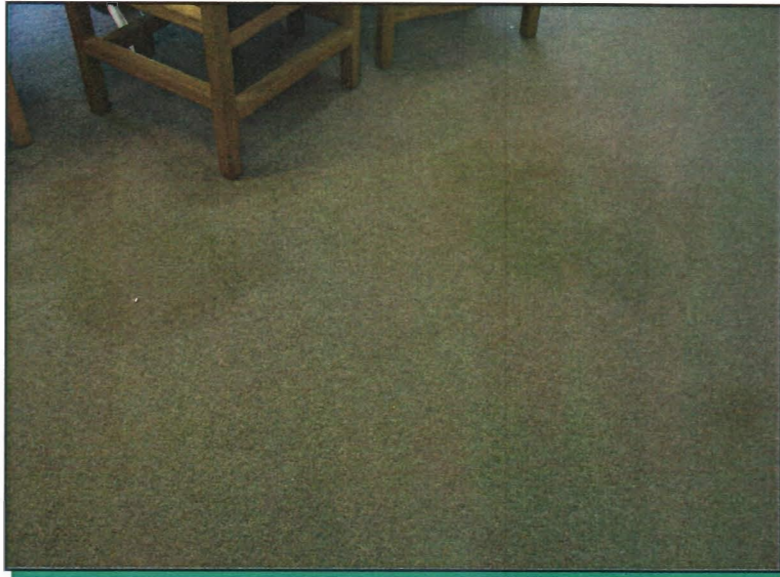
Stained carpet

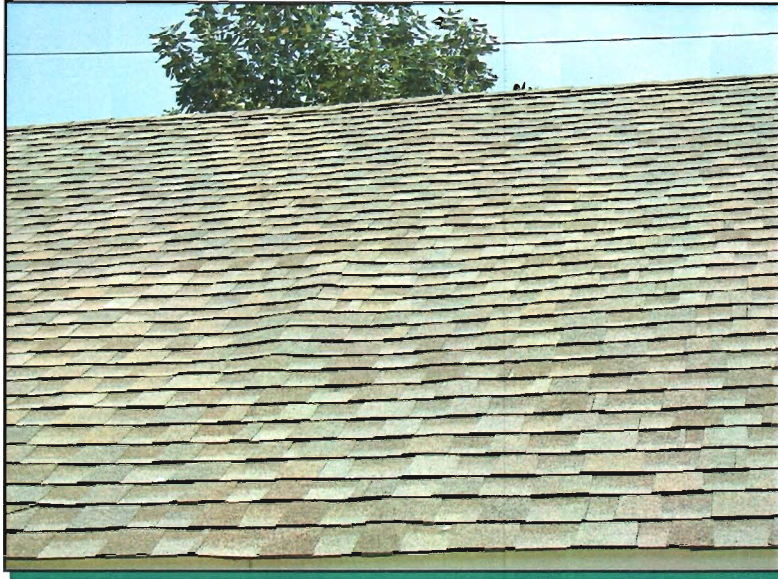
Sheathing deflection of asphalt shingle roof

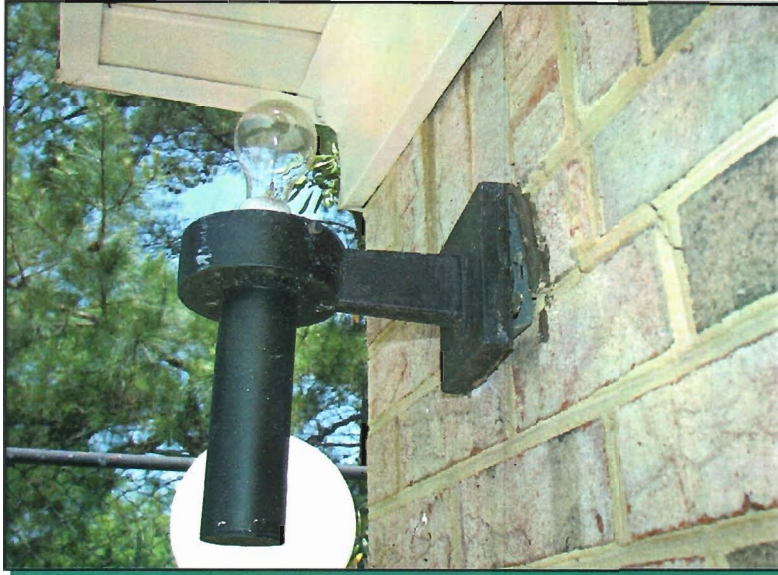
Damaged light fixture - *replace through the operation budget*

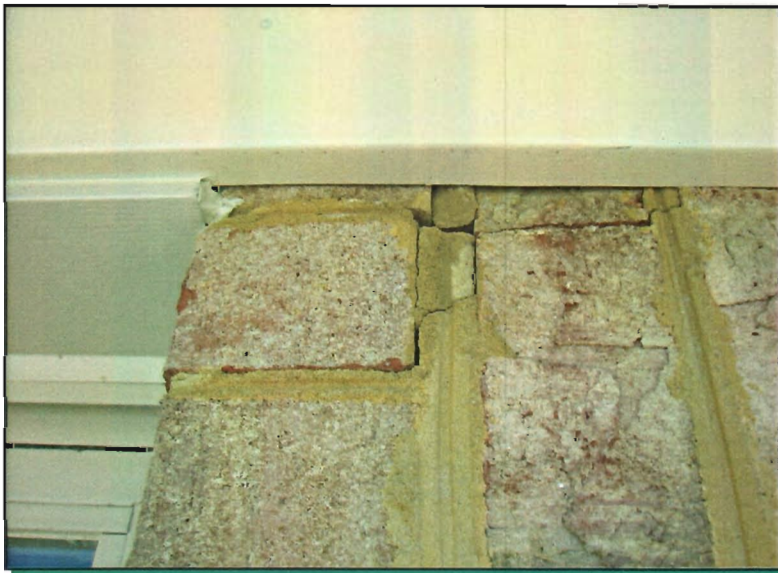
Deteriorated mortar - *repair through the operation budget*

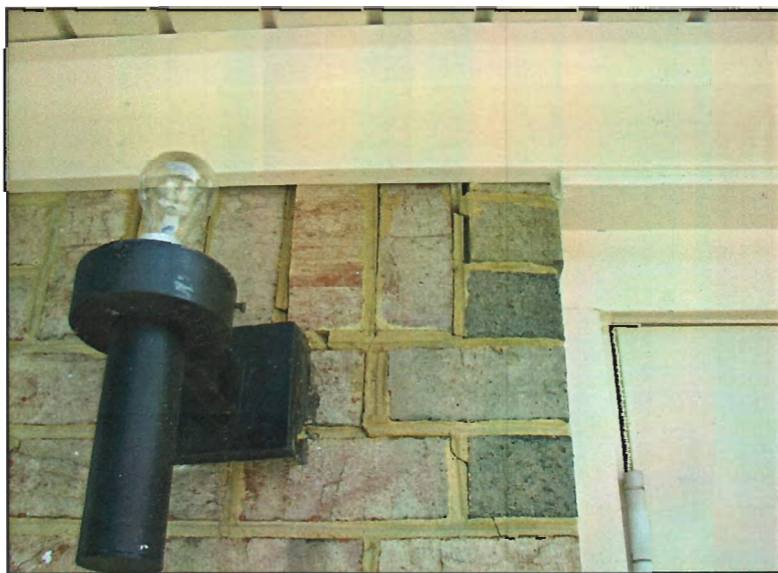
Damaged light fixture and deteriorated mortar- *replace and repair through the operation budget*

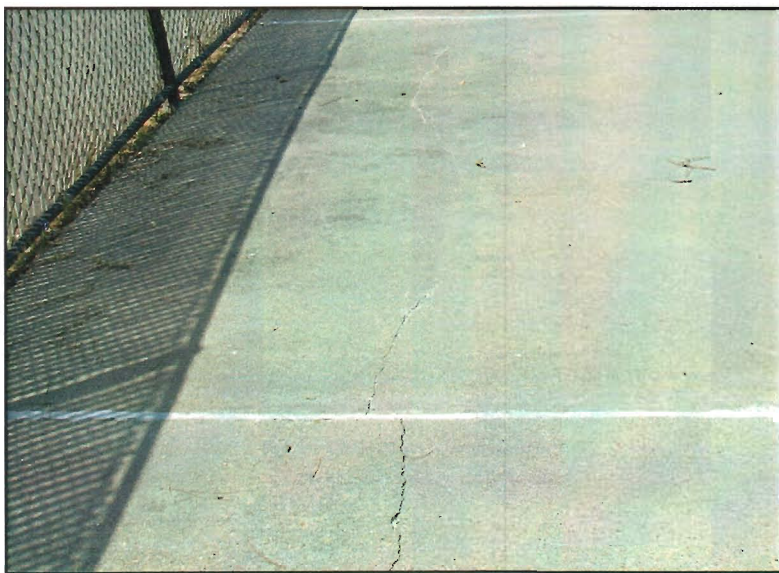
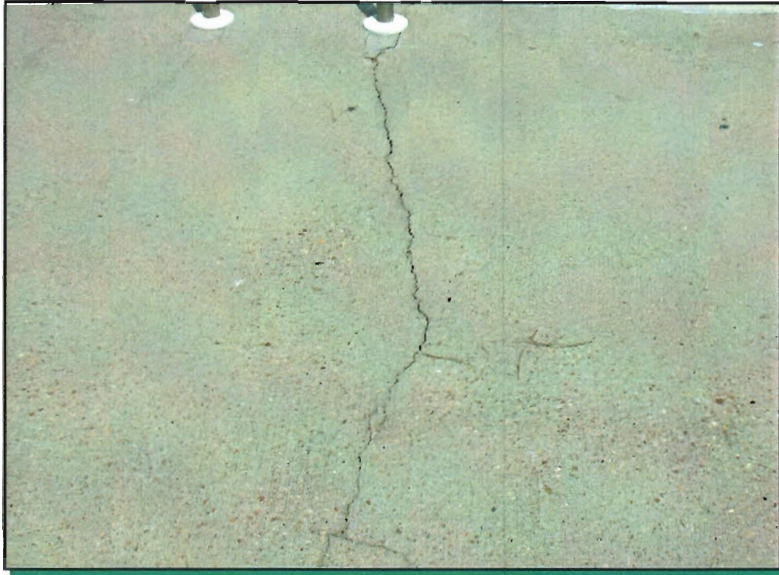
Cracked concrete deck

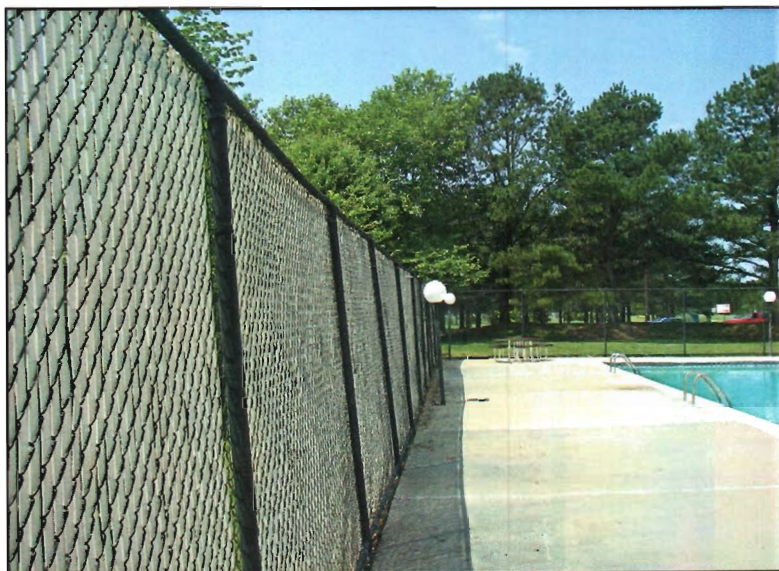
Pool fence lean

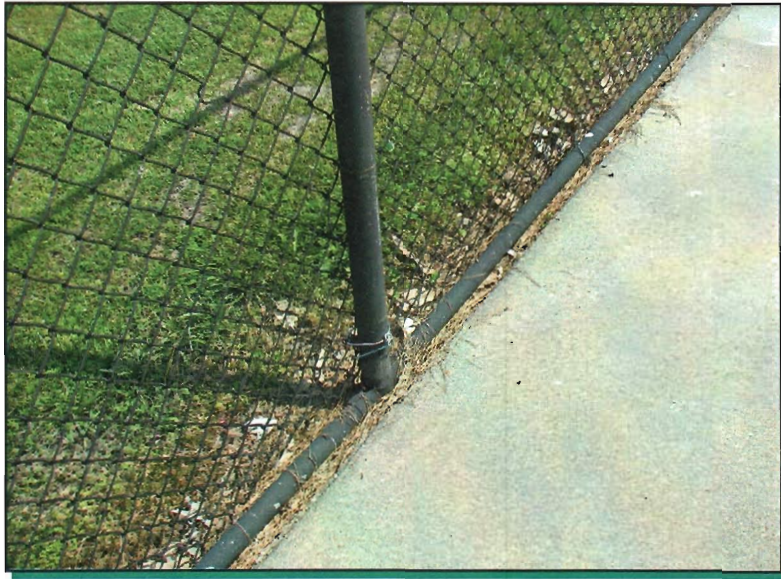
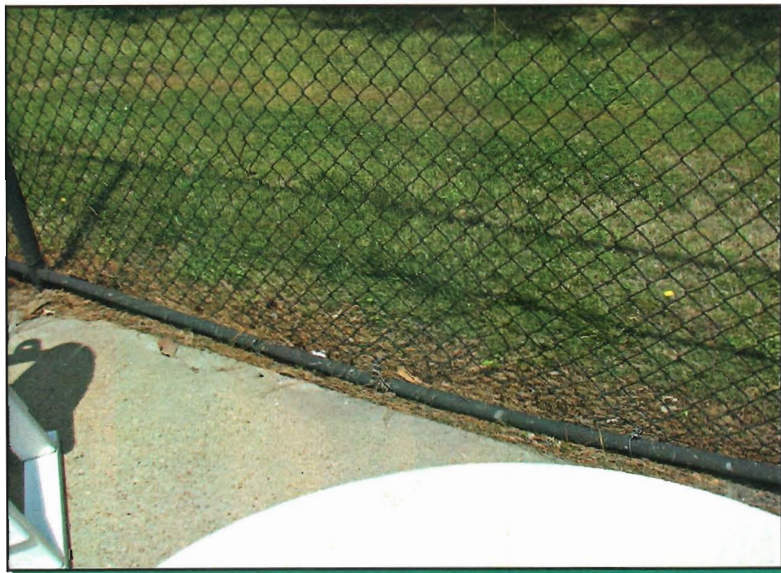
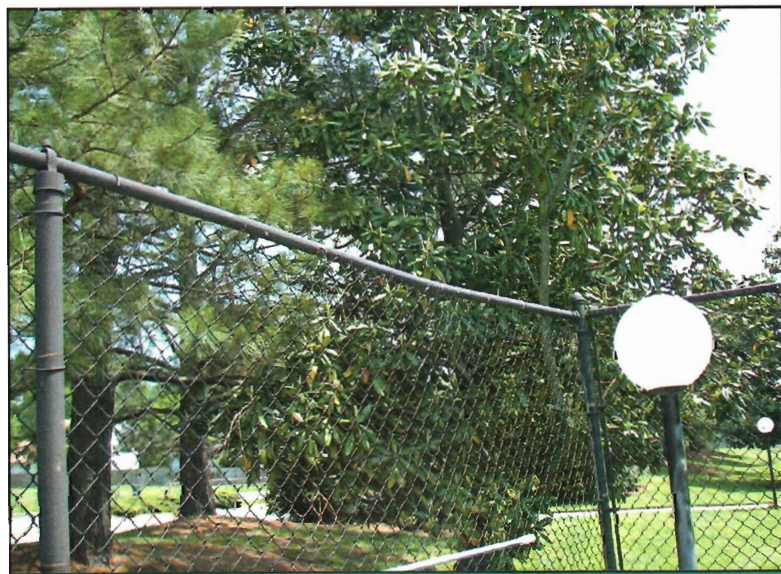
Damaged cross bar of pool fence

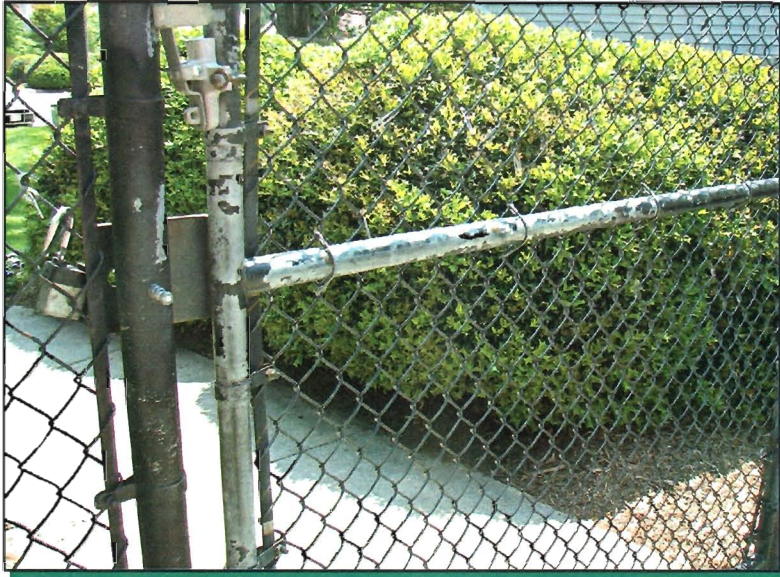
Finish deterioration of pool fence

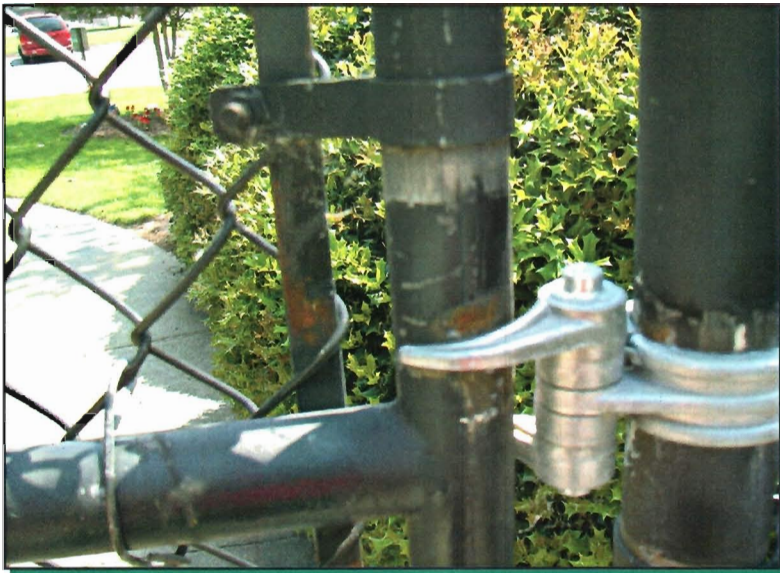
Rusted pool fence

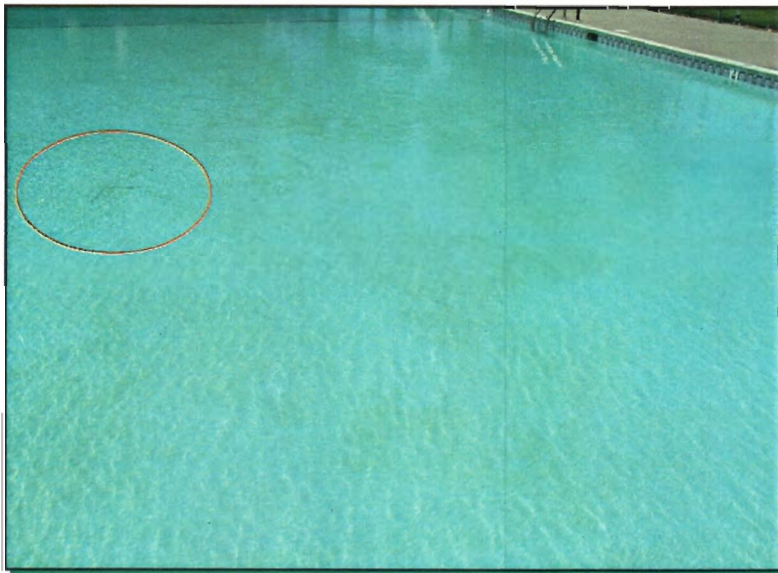
Spalled and stained plaster finish

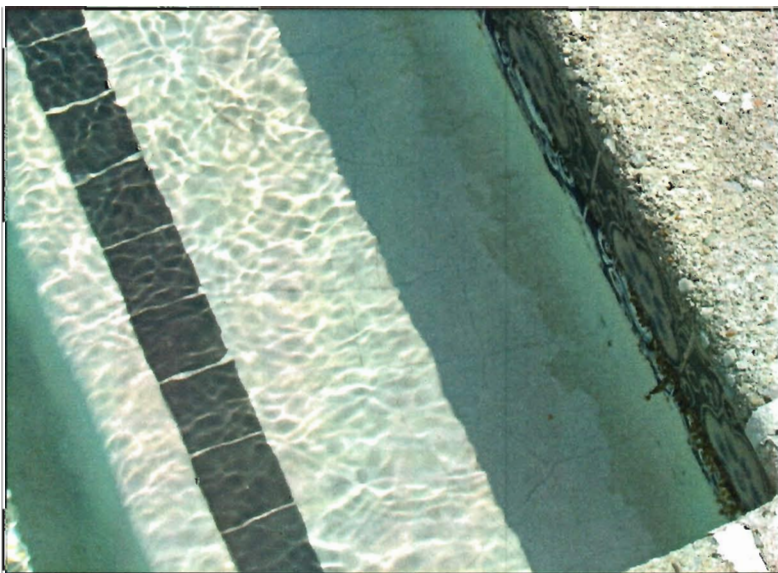
Cracked plaster finish

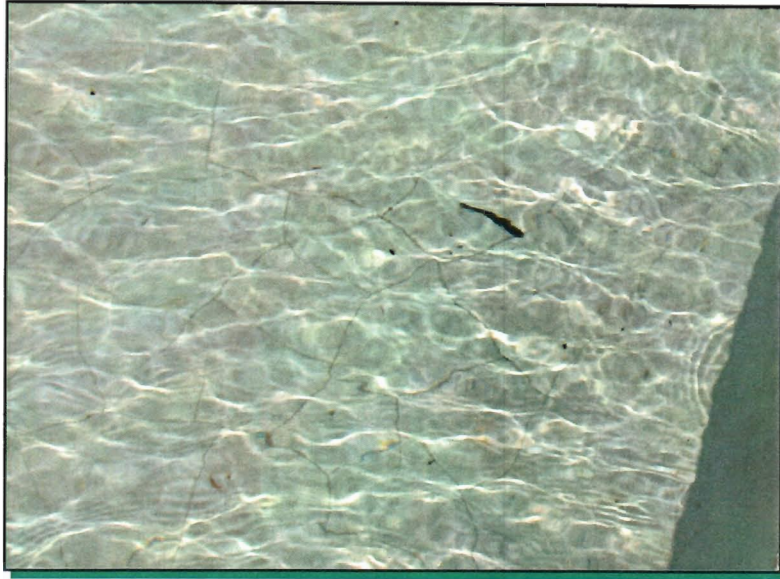
Cracked plaster finish at wading pool

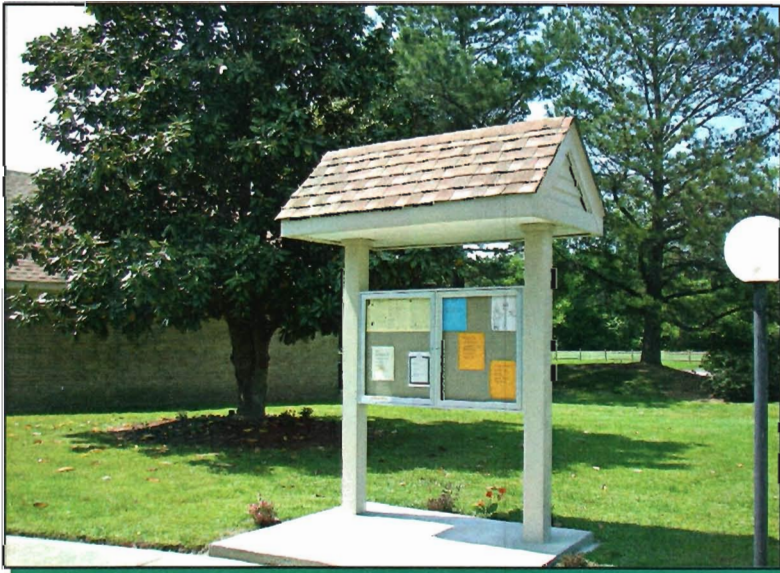
Informational signage - *replace through the operating budget*
